**EVALUATION OF INTEGRATED SEISMIC HAZARDS AND GROUND FAILURE IN
PULL-APART BASINS DURING 1999 KOCAELI EARTHQUAKE, TURKEY**

**COLLABORATIVE RESEARCH BETWEEN THE UNIVERSITY OF TEXAS AND
WILLIAM LETTIS & ASSOCIATES**

USGS Award No. 01HQGR0043
(University of Texas at Austin)

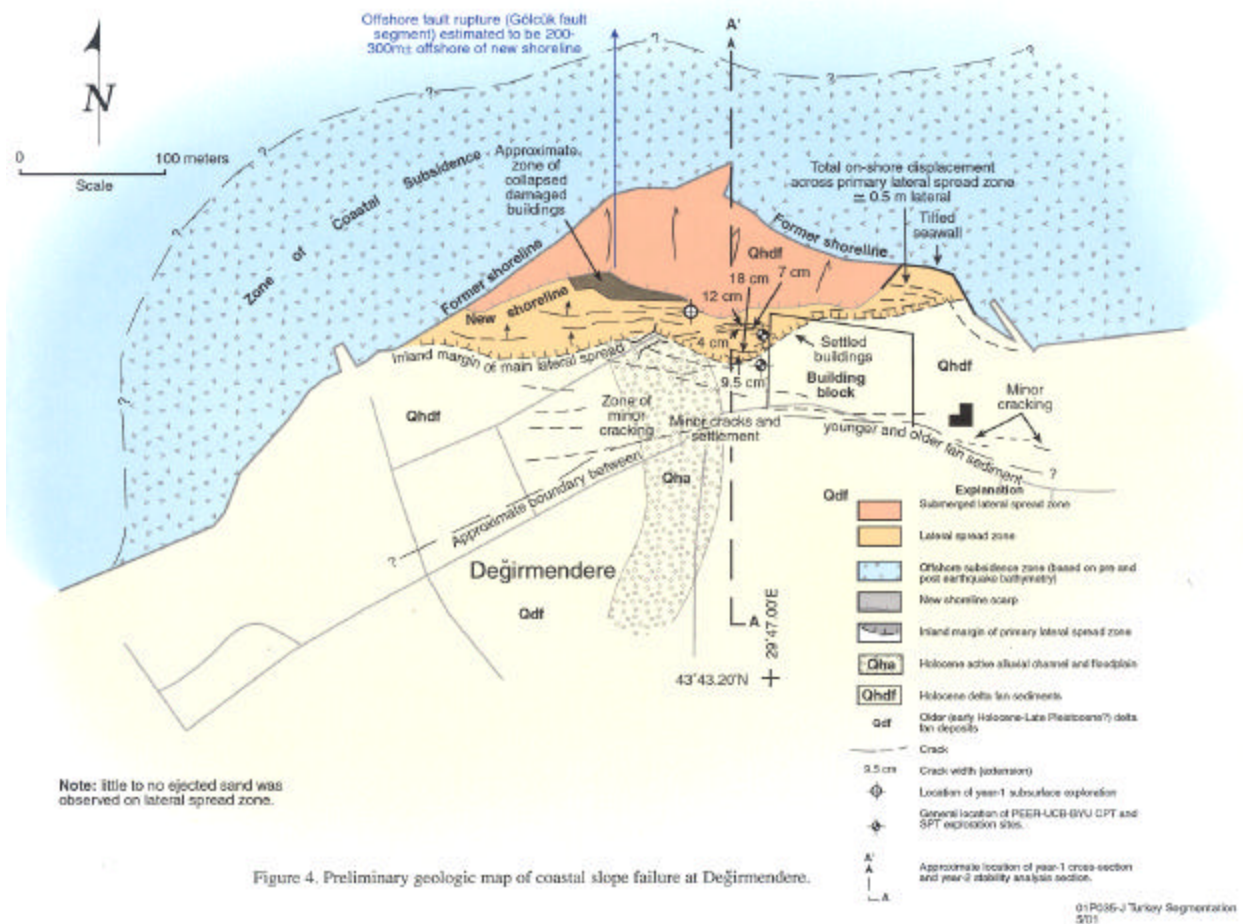
A major coastal landslide occurred in a delta fan deposit in the city of Degirmendere, which is located on the southern coast of Izmit Bay and within the Karamursel pull-apart basin (Figure 1). A map of the landslide is shown in Figure 2. The area of the slide extended approximately 300 m along the coast and 75 m inland. A significant amount of land was submerged after the failure, creating a completely new coastline. Cracking extended inland, beyond the extent of the submerged area, but no evidence of liquefaction was observed.

Figure 2. Coastal landslide and subsidence at Degirmendere

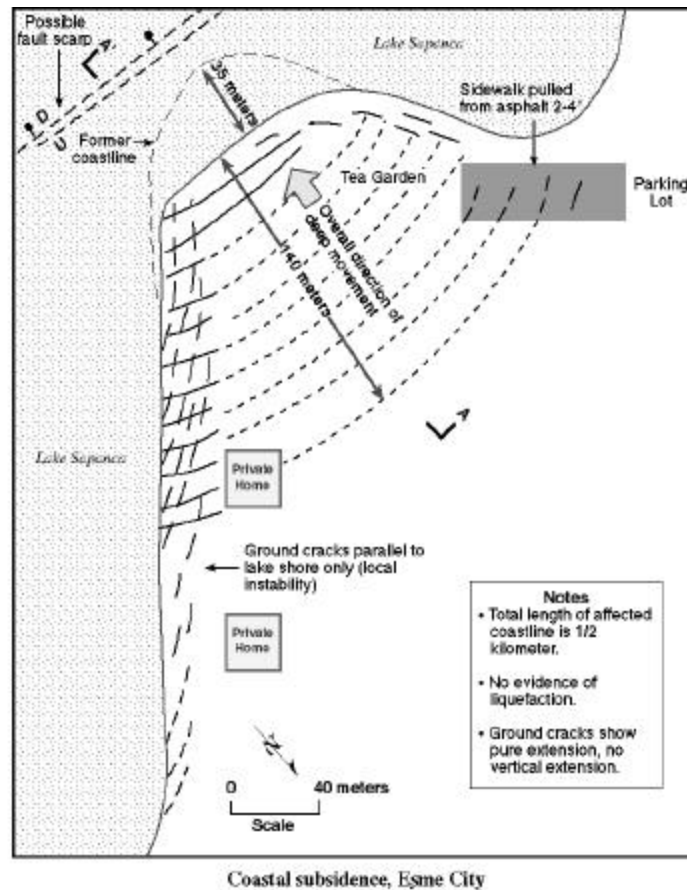
Esme is a town located on the north shore of Lake Sapanca (Figure 1), situated on alluvium deposited from the hills north of the lake. A large slide occurred along the coast in Esme, within delta sediments deposited by a creek. The area of the slide extended approximately 50 m along the coast and 35 m inland. The inland extension of ground cracks was about 150 m. Based on observations after the earthquake (EERI 2000), ground cracks showed pure extensional movement with no rotational component (Figure 4) and no evidence of liquefaction was observed. No subsoil information was available for this area.

Figure 4. Mapped ground cracking at tea garden in Esme
